FABCO INDUSTRIES, Inc
VEHICLE REFUELING/STORAGE LOT
TEST PROGRAM

Executive Summary

Introduction:

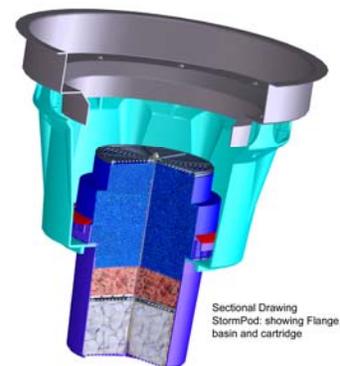
A StormPod is comprised of three elements: a plastic flange to adapt the filter to a round grated frame opening, a plastic basin to collect runoff water, debris etc, and a filter cartridge that fits into an opening at the bottom of the basin.

The StormPod can be equipped with any of 4 standard user replaceable filter cartridges. Additionally the filter body design is adaptable to modification with other filtering technologies as they become available. In this study a prototype cartridge was employed that was built using a new filtering media identified as Poly-P. In all 3 types of cartridges were used in the study: Standard, Heavy metals and Poly-P.

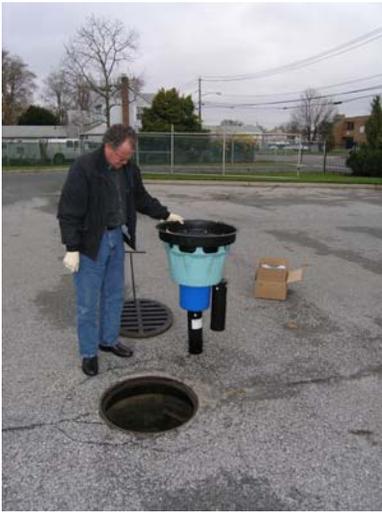
Prior to attaching the mounting tubes, a small hole (3" dia) was drilled in the bottom of the StormPod basin to allow water to pass out and into the sample bottle. A piece of round plastic material with a 4" diameter hole in the center was glued to the bottom of the filter cartridge. This flat plastic washer-like device insured that water leaving the cartridge would be directed out of a central hole into the mounting tube and to the sample bottles.

The black Nalgene tubes were mounted vertically (extending downwards) from the bottom of the StormPod basin and filter cartridge using clevis pins so that they could be removed when required.

After completing these preparatory steps the white sample bottles were then inserted into the mounting tubes and the assembly was fixed, using the clevis pins, to the StormPod basin and cartridge body. In this configuration the bottle under the Basin would collect the sample of untreated water whereas the bottle under the cartridge would catch a sample of treated water.

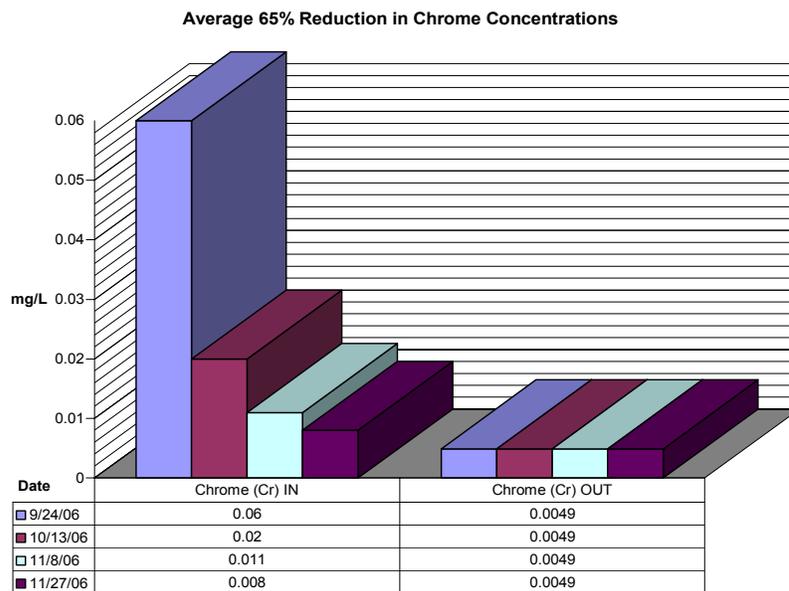
Graph 1: Reduction of Heavy metal Chromium form storm water

Pollutant	Minimum Reduction %	Maximum Reduction %	Average %	Graph
Oil and Grease	25%	45%	35%	-
Chrome	44	92	68%	1
Lead	36	94	73%	2
Zinc	47	70	57%	3

- b. The data obtained for heavy metals clearly stands on its own merits and also confirms that the filter cartridges can treat multiple pollutant species simultaneously.
 - i. Overall the Standard cartridge and the special HV metals cartridges performed similarly during the test. However, we would expect that the extra filtering capacity available in the HV metals cartridge would allow the unit to treat both higher concentrations of heavy metals over a longer period time.

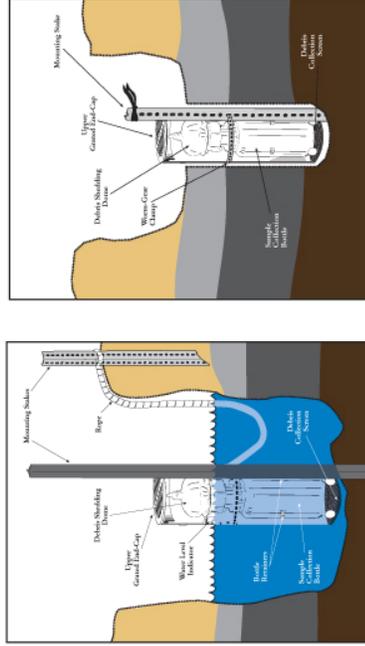
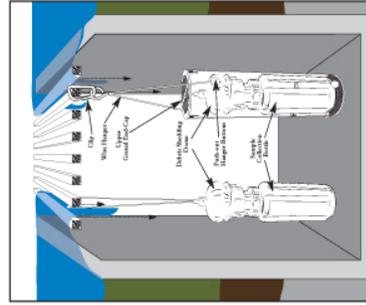
Appendix B, fig 2

NALGENE® Storm Water Sampler and Mounting Kit
Cat. Nos. 1100-1000 and 1150-1000

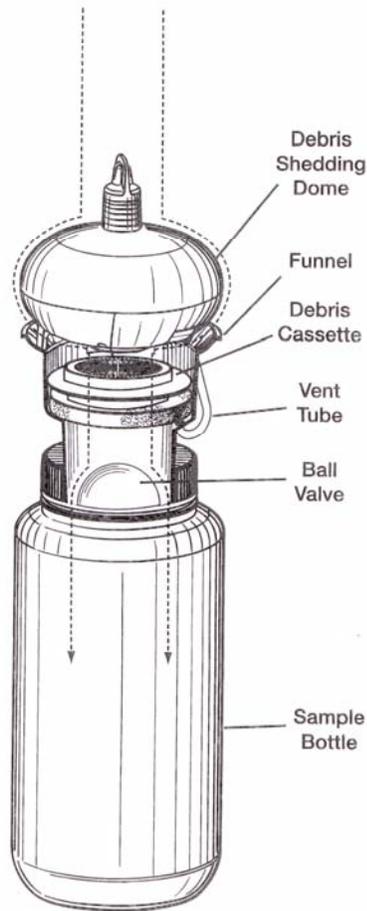
Fig. 1

Storm Water Sampler
NALGENE Cat. No. 1100-1000
(Single use Disposable)

Collects a full one liter first flush grab sample into a 1000ml NALGENE® HDPE sample bottle within the first minutes of storm water outfall flow. Floating ball valve automatically closes off sample port after bottle is full to prevent comingling with later run-off and volatile analyte loss. Meets EPA NPDES MSGP (Fed. Reg. FRL-6880-5 10/20/00) and most state general permit grab sampling requirements. Sample bottle is leakproof when closure is applied. Sampling device intended for one-time use. Use with Storm Water Mounting Kit (catalog number 1150-1000). Not for oil and grease sample collection.

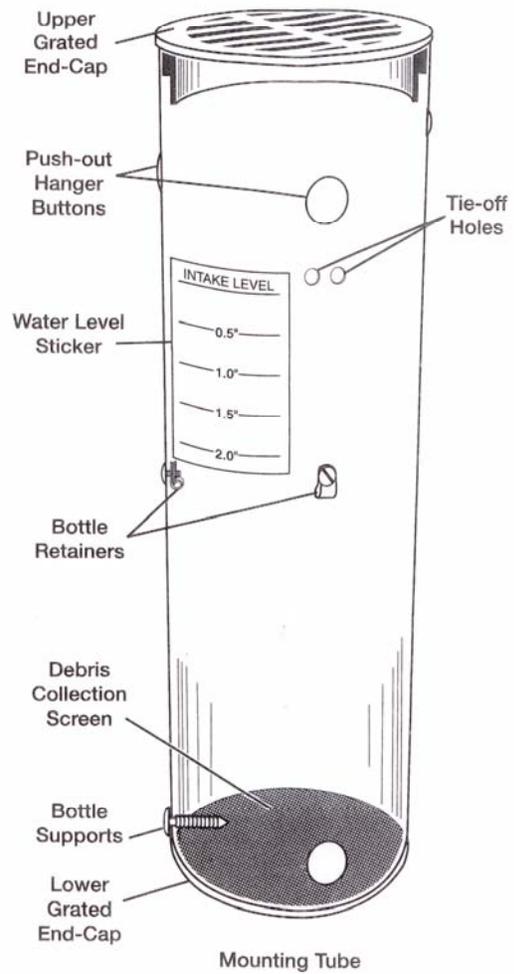
Storm Water Mounting Kit
NALGENE Cat. No. 1150-1000
(Reusable)

Mounting tube can be positioned in storm water ditch, stream or grate outfalls. Use the wire hanger and carabiner-style snap to suspend the tube from a storm grate. For stream or ditch mounting, position the steel stake or a T-post in the outfall, and secure the mounting tube using the stainless steel worm clamp. Position once, and reload with disposable samplers (1100-1000 sold separately). Complete installation instructions included.
